# Pole audits for Tennis Clubs

SERVICE BY D&A LIGHTING SYSTEMS

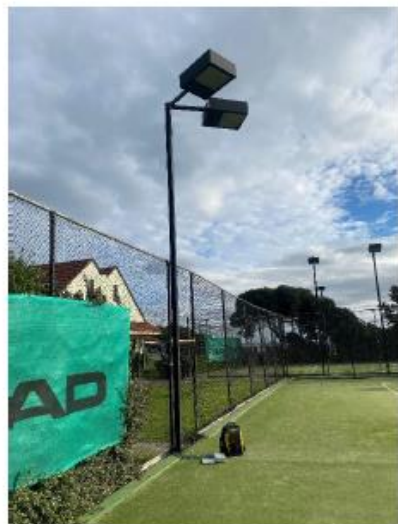
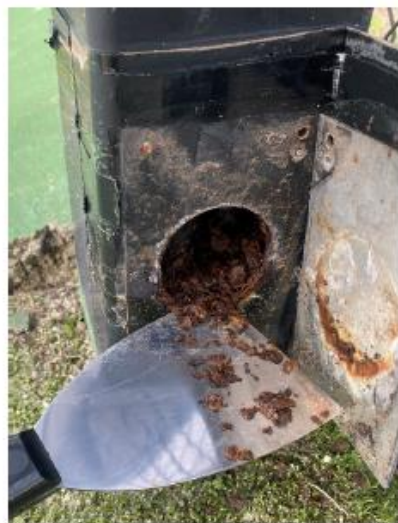
## Pole 4

4	4.10	3.66	2.40	2.28
---	------	------	------	------

Pole 4 with a nominal wall thickness of 4mm shows extreme signs of internal deterioration due to corrosion.

As identified on the UTG test, the wall thickness of the pole at ground level has almost halved over its lifetime and is now at a critical point.

With a wall thickness of 2.28mm the strength of the steel is not suitable to support the attached light fittings and is considered 'high risk' and should be replaced.

- Install new pole and foundation adjacent existing.

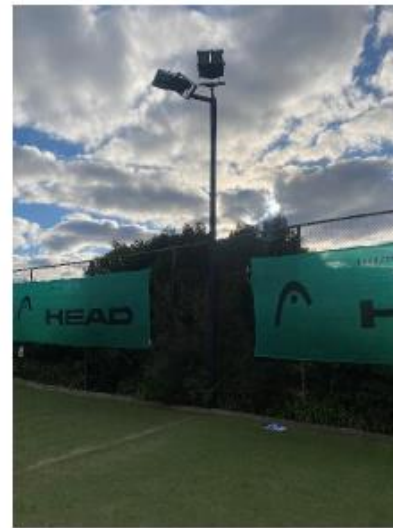
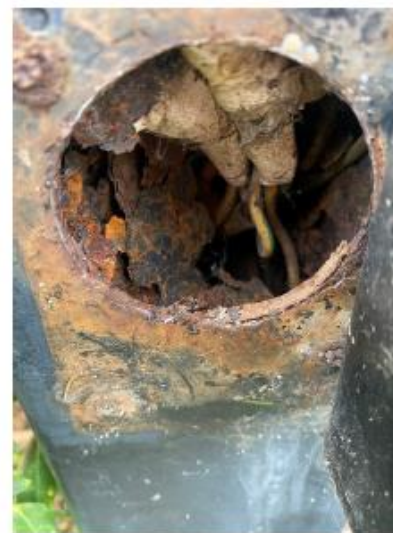
## Pole 6

6	3.97	3.85	3.90	2.47
---	------	------	------	------

Pole 6 has a nominal wall thickness of 4mm. Being one of the original poles installed at Williamstown, it is also suffering from severe internal rust.

UTG tests show that there is significant decay around the base of the pole, measuring just 2.47mm on one face. Despite a solid reading on the adjacent face of the pole of 3.90mm and not being categorized as 'high risk', this pole is still very much at risk.

- Install new pole and foundation adjacent existing.
